Case History

Bay Area UNDERPINNING

Twelve ECP Steel Piers™

Recovered Three Inches of Lost Floor Elevation

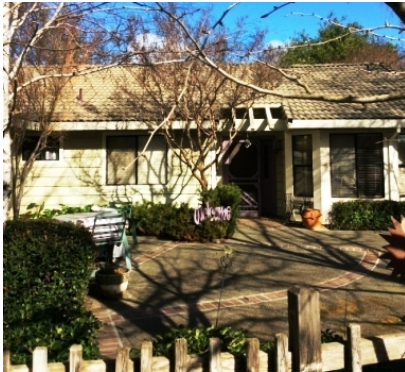
Earth Contact Products' steel piers stabilized and raised this residence up to three inches. Twelve ECP foundation brackets were mounted under the footings and twelve ECP Steel Piers™ were driven 44 feet deep, on average, to firm bearing. Each pier was field tested to a load between 22,500 and 23,750 pounds to confirm suitable firm bearing. Each steel pier is now supporting 12,360 pounds, which is the working load required to recover lost elevation and provide long term support.

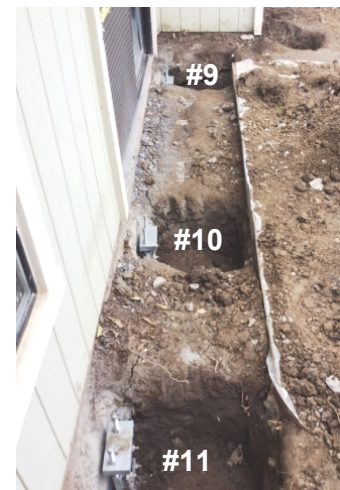
Piers #9, #10 and #11 are seen here installed and supporting the structure.
